## 418 Willow Creek Lane

Brookhaven, GA 30319 · Prepared for Jordan Ellis (sample)

Jamie Cole · WALKED Sample Inspector · SAMPLE-HI-0000 · sample@trywalked.com

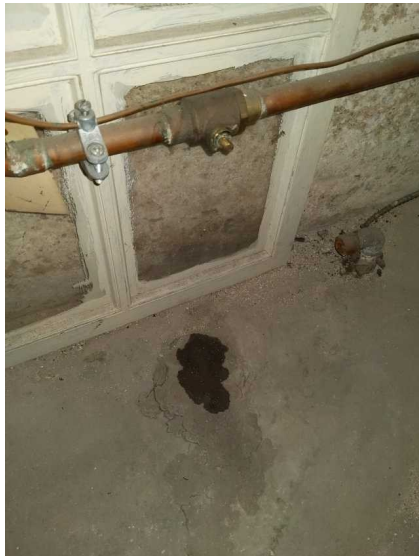
Cover = #1 Hire a Pro (pipe leak).

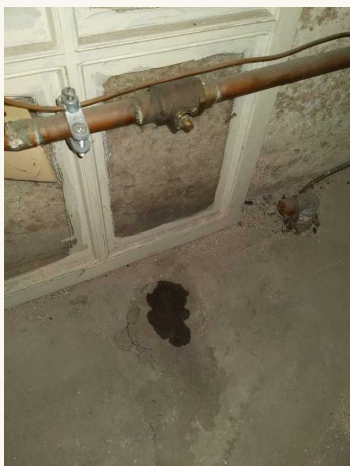
#### Copper supply · active leak / puddle

Copper line over a wet spot on the floor — active plumbing leak. Hire a Pro.

Licensed plumber. Find the drip, repair the joint, dry the area.

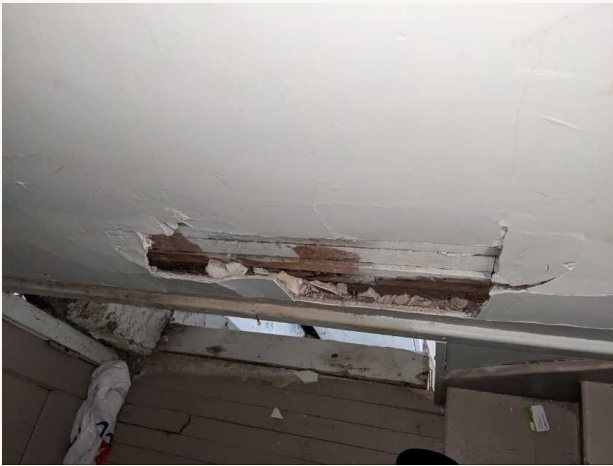
### Ceiling / soffit · water damage through lath

Plaster failed; stained lath shows behind it.  
Water damage — Hire a Pro.

Roofer / exterior carpenter. Trace the leak, then repair the ceiling.
