# 902 Meadowbrook Drive

Carmel, IN 46032 · Prepared for Sam Rivera (sample)

Jamie Cole · WALKED Sample Inspector · SAMPLE-HI-0000 · sample@trywalked.com

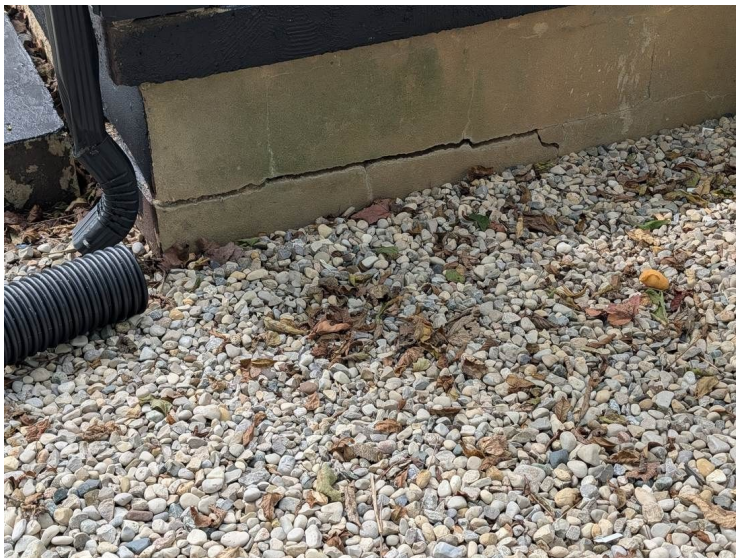
Cover = #1 Hire a Pro (foundation crack).

Horizontal crack along the block course where the downspout lands. Hire a Pro — foundation.

Foundation / masonry. Evaluate the crack; keep water pulled away.

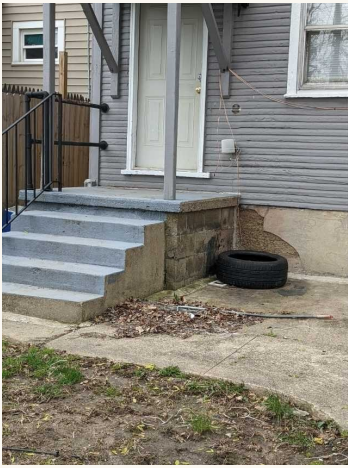
### Rear steps · parging failing at foundation

Parging is crumbling off the foundation beside the painted steps. Hire a Pro.

Mason / foundation. Repair coating; check for moisture behind it.

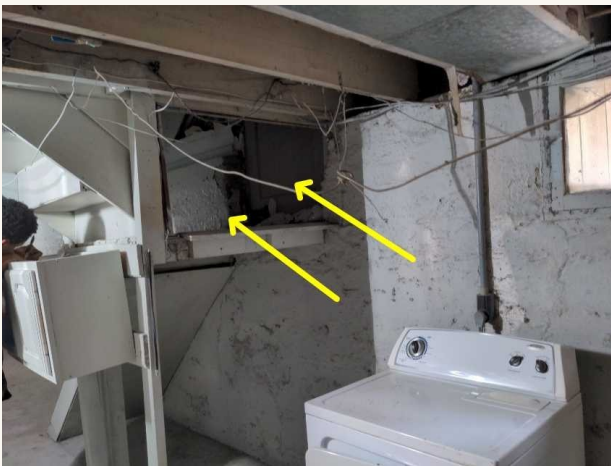
### Basement · open wall bay + hanging wiring

Open wall opening under the stair framing and loose wiring over laundry. Hire a Pro.

Licensed electrician. Secure and cover.

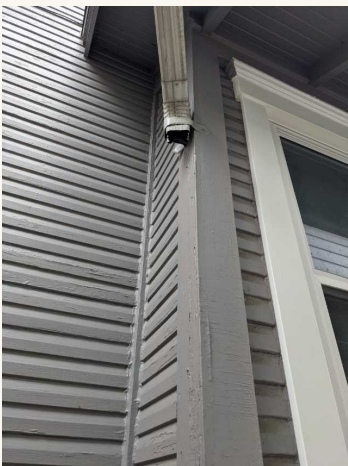
### Downspout · section broken off

Upper downspout is open — reconnect so water leaves the wall.

New section + straps; extend discharge away from the house.

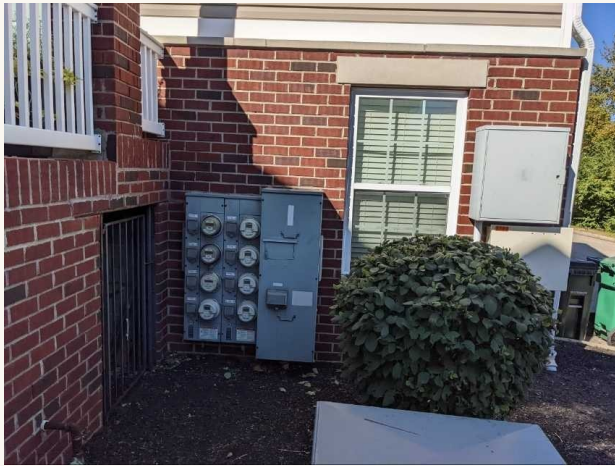
### Meter bank • clear the bush

Plant growth crowding the meters and service gear. Clearance is DIY.

Trim back; keep a clear working space at the meters.

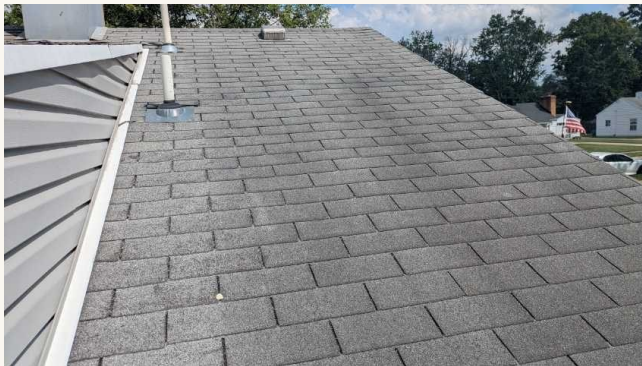
### Roof • aged three-tab / algae staining

Granule wear and dark algae streaks from the ladder walk. Age / budget note.

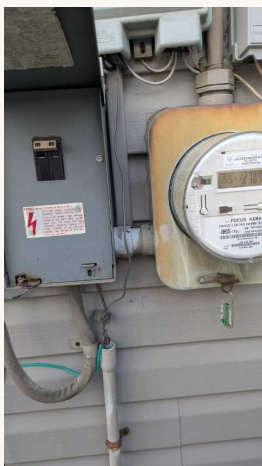
### Service entrance • meter / disconnect

Exterior service disconnect photographed with cover open. Equipment note.
